Field Survey of 2021 Typhoon Rai –Odette- in the Philippines

Typhoon Rai struck the Philippines on 16th December 2021, damaging and inundating many coastal areas in the Visayas region. The typhoon brought with it violent winds, storm surges and high waves, which left a trail of destruction and debris in its wake. In order to understand the various damage mechanisms, the authors conducted a field survey to measure the water level heights reached by the storm surge at several locations in the provinces of Cebu and Bohol. As part of the survey, local residents were interviewed to understand the phenomena and survey the heights reached by the storm surge. The maximum storm surge level measured were 2.54 m and 4.06 m across coastal towns in the provinces of Cebu and Bohol, respectively. Finally, some interesting characteristics of the storm surge are summarised, and the lessons learnt in terms of disaster risk management are discussed.

Storm surge, Philippines, Typhoon Rai, Field survey

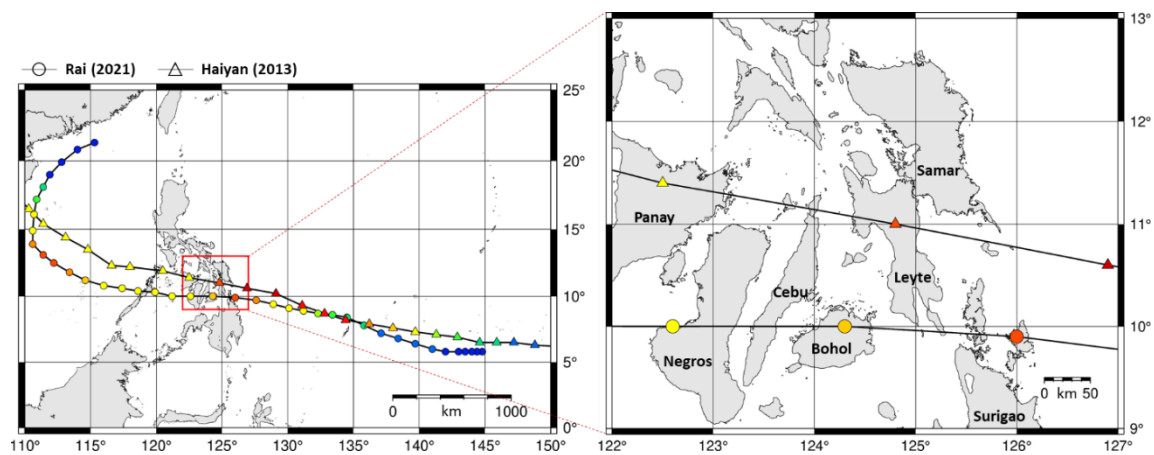
Figure 1. Typhoons Rai and Haiyan Best Track Data from the Japan Meteorological Data (JMA).

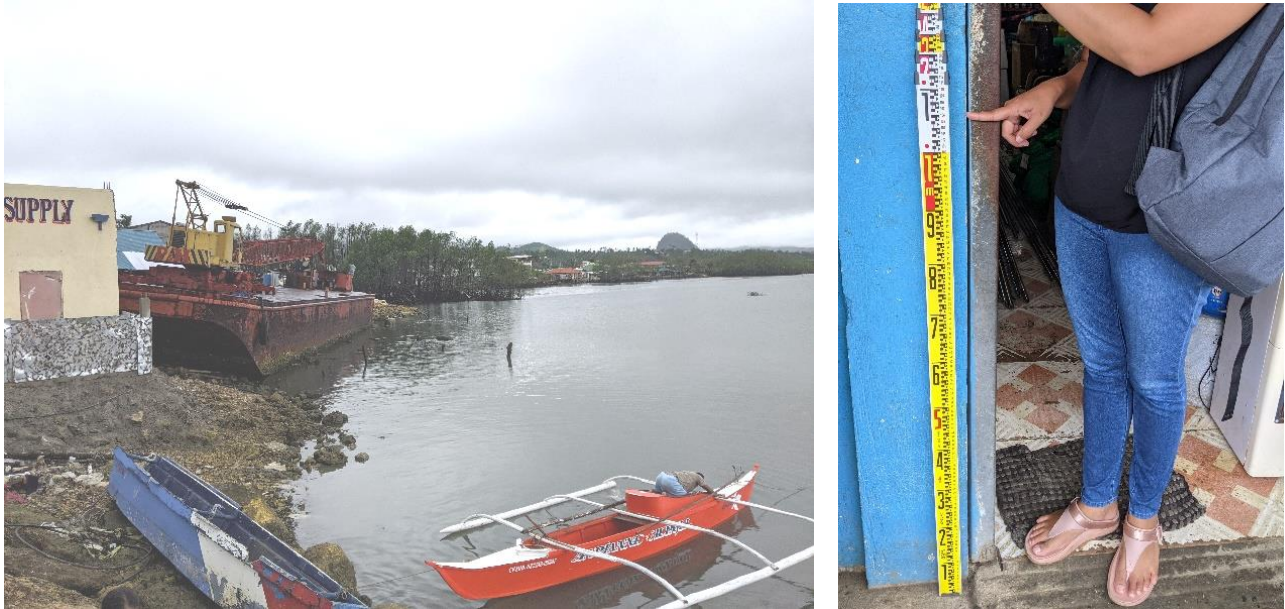
Figure 10. Left. Barge slammed into houses close to Tubigon port. Right. Inundation level in the shop seen on the left side of the figure.

The town is located in the northern part of Bohol, and has a ferry port with numerous daily connections to Cebu Island. A barge was carried by the surge and slammed into houses next to the port (See Figure 10), although many of them were subsequently rebuilt. At a house next to this barge, the inundation level reached 1.07 m above the floor, although there was substantial run-up that reached the main church of the town (situated around 430 m from the shoreline).

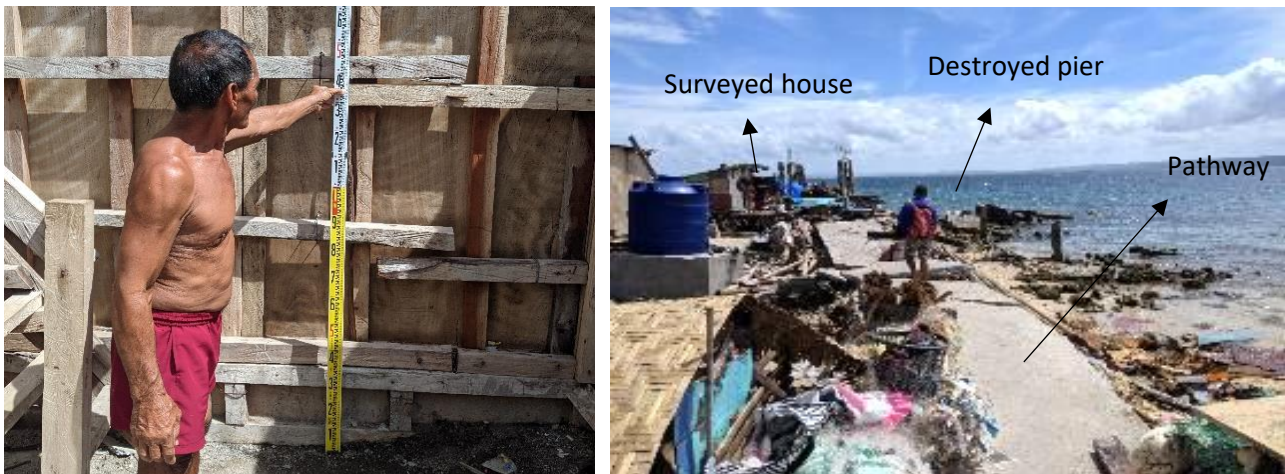
Figure 11. Left. A resident indicates the level of the water in front of the barangay hall. Right. At the right side of the photo is one of the houses surveyed in front of what is left of the pier (structure on the right side)

The storm surge submerged the low-lying Pangapasan island to a depth of 1.36 m (as measured in front of the barangay hall, see Figure 11). Many of the wooden buildings in the islands, and others that were sturdier but situated next to the sea, were destroyed by the waves. An elevated pathway that runs around the edge of the island, which offered some protection to houses situated inside of it (as opposed to those between it and the beach, which suffered more damage). One of the barangay councillors was interviewed, who reported that his house –a stilted construction located next to the shoreline- was washed away at 22:00. This happened due to the waves lifting his house and then transporting it away (although he had evacuated to his mother’s house within the island).

The residents of a wooden house situated next to one of the piers in the island (which was completely destroyed by the waves, see Figure 11) indicated that the water reached a level of 1.22 m from the floor of the house). They initially evacuated to the school, which was destroyed and this forced them to relocate to the 2nd floor of another house.
